# Inspection Report

## THE HOME INSPECTOR

Your Property

| Inspection Date | May 11, 2016 |

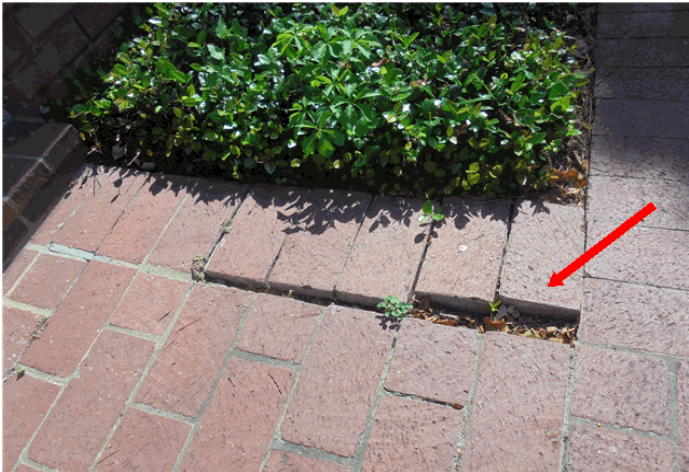
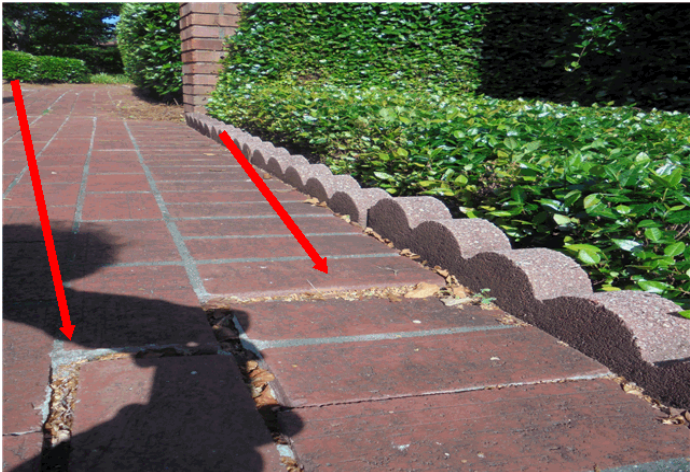
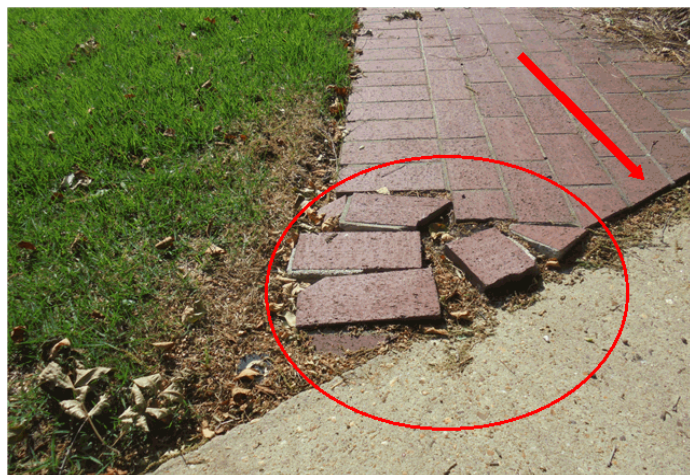
3) Sidewalk Conditions      R      The surface was raised or settled. This may cause tripping hazards. These should be repaired for safety.

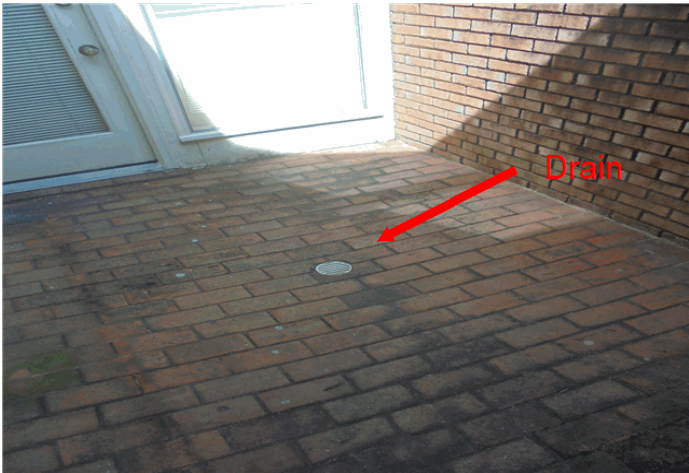
6) Walled In Patio      AS

Area is drained by floor drain. There was no evidence at the time of the inspection of backup. This drain should be maintained and cleaned to allow rain water to flow freely.

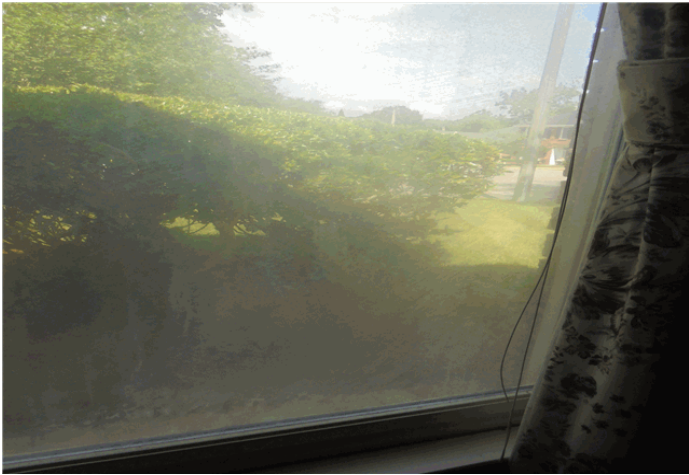
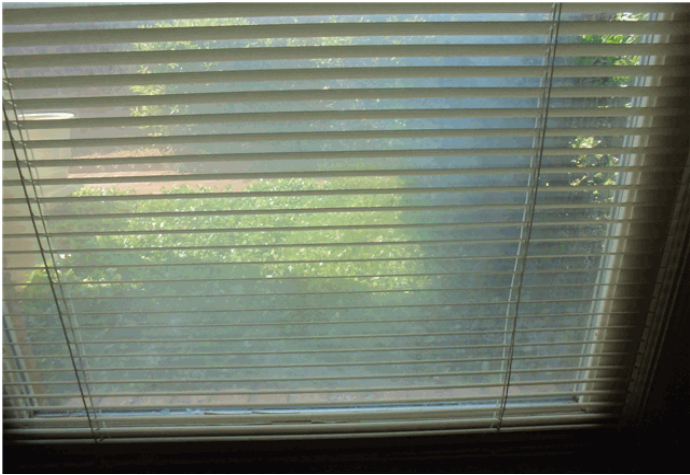
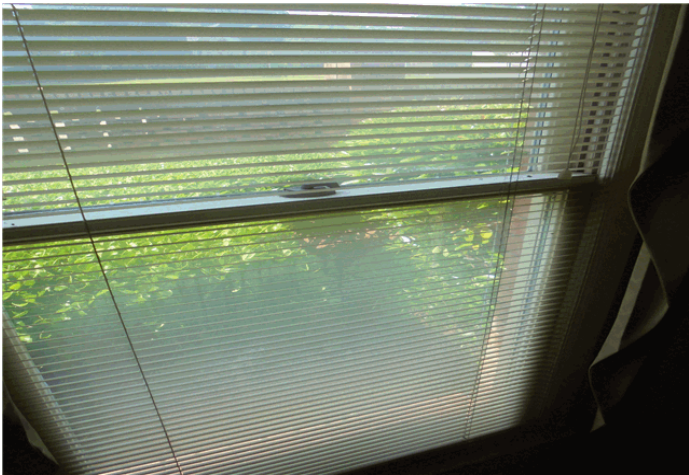
8) Window Conditions

The thermal pane window(s) at Front room, Front Bedroom, Dining Room and Kitchen appear to have lost its / their thermal seal. Moisture, fogging, and hazing are common signs of this condition. While mostly cosmetic, this condition is generally not repairable. Correction would require replacement of the window(s) or window pane(s). Recommend repairs as needed.

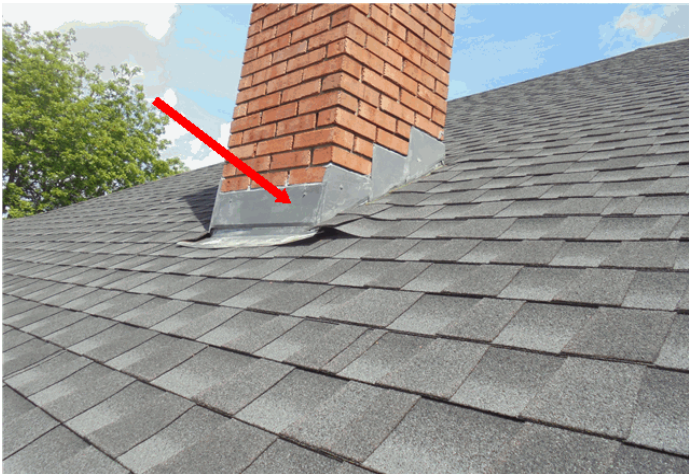
13) Roof Covering Condition

The roof covering shows normal wear for its age and appeared to be in serviceable condition at the time of the inspection. The shingles along the bottom edge of the chimney flashing were raised and could allow water to enter the house. It is suggested that a "Licensed Roofing Contractor" be contacted for further evaluation and repair.

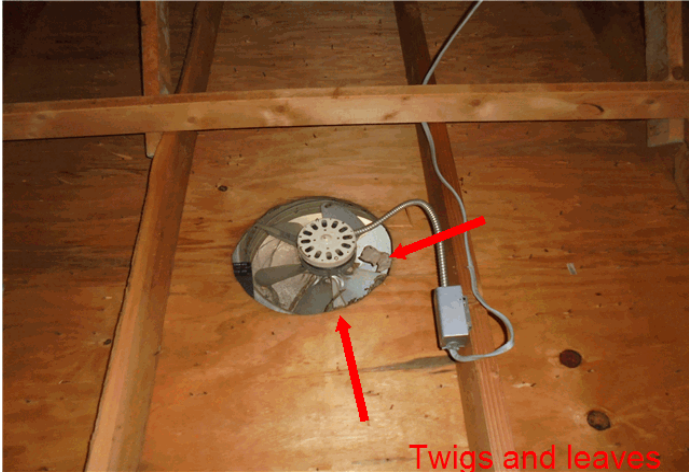
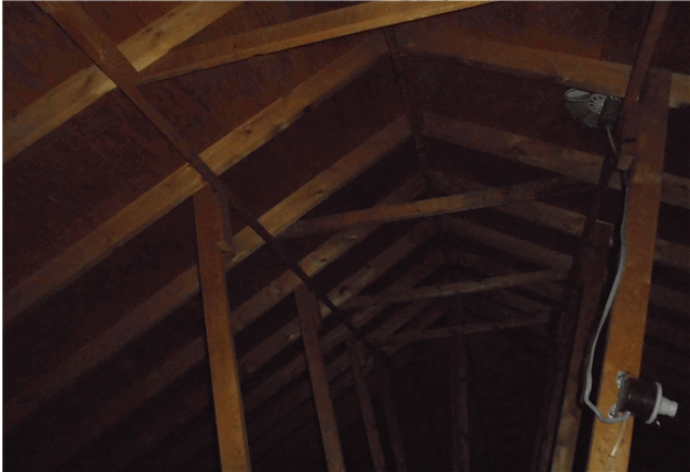
**16) Attic Conditions**      **R**      The visible and accessible portions of the attic appeared to be in serviceable condition at the time of the inspection.

**Attic Ventilation Conditions**      The power fan were too high to test. The fan nearest the attic ladder had small twigs and leaves in it and probably doesn't work. The other power fan did not have twigs in it.

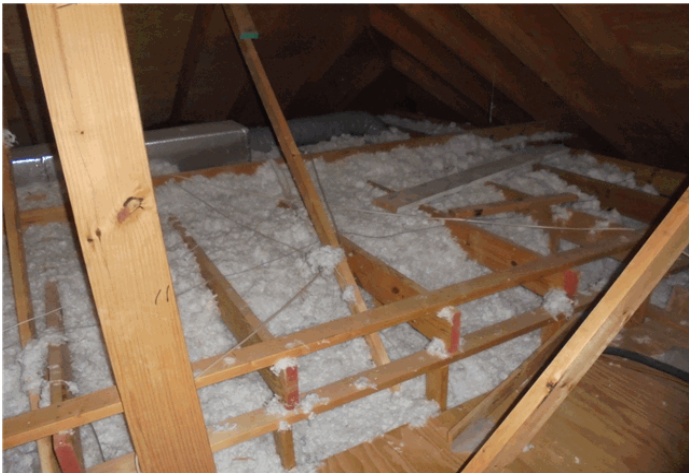
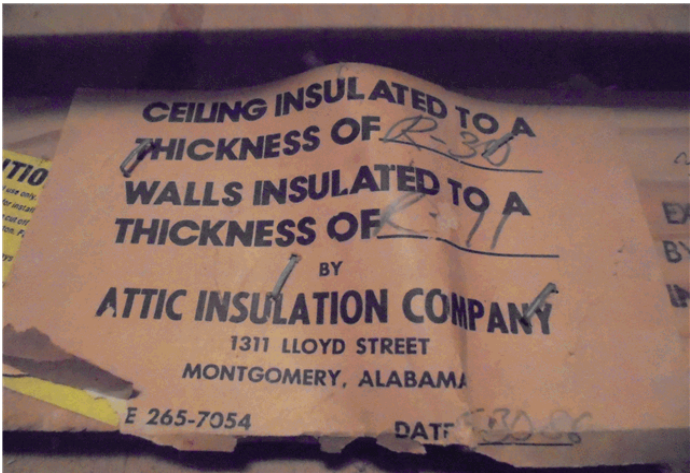
**17) Attic Insulation Conditions**      **AS**      The attic has blown-in insulation. The approximate depth of the insulation is 10+ inches, which appears adequate.

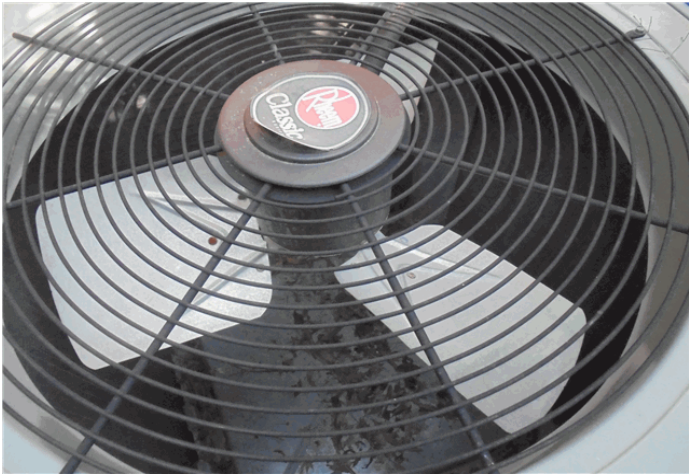
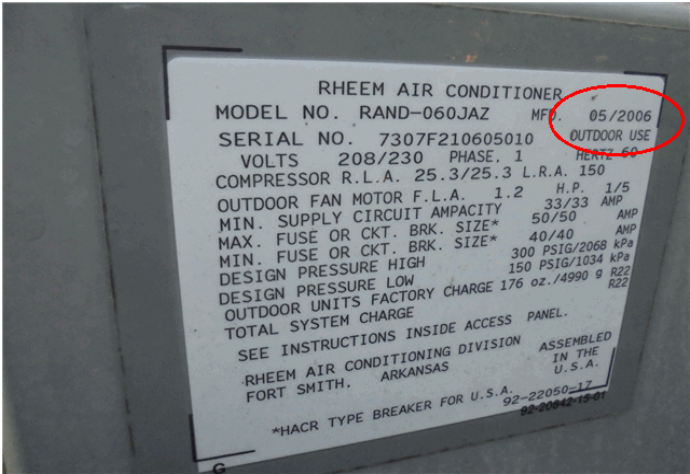
| 22) AC Unit Conditions | <div>AS</div> According to the plate on the compressor unit is was manufactured in May, 2006 so this unit is approximately 10 years old. |

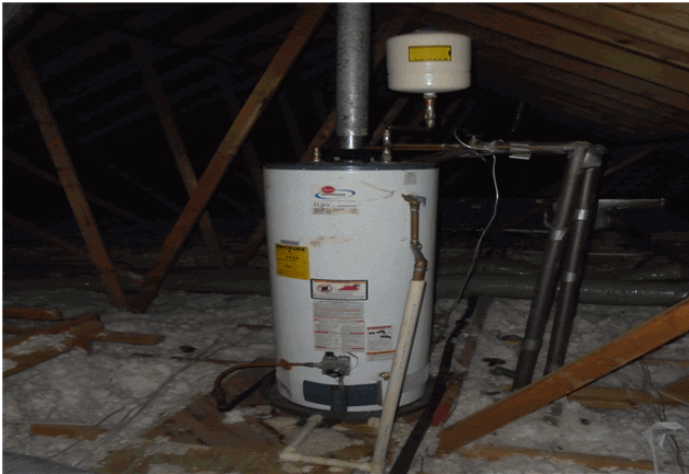
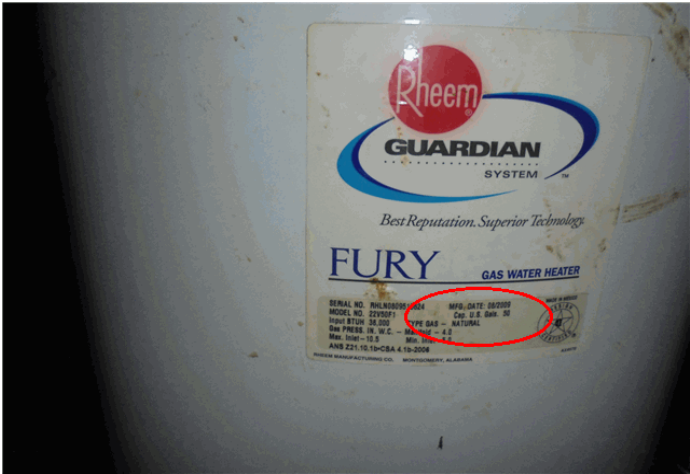
| 29) Water Heater Conditions | AS      Manufacture date of Aug, 2009. |

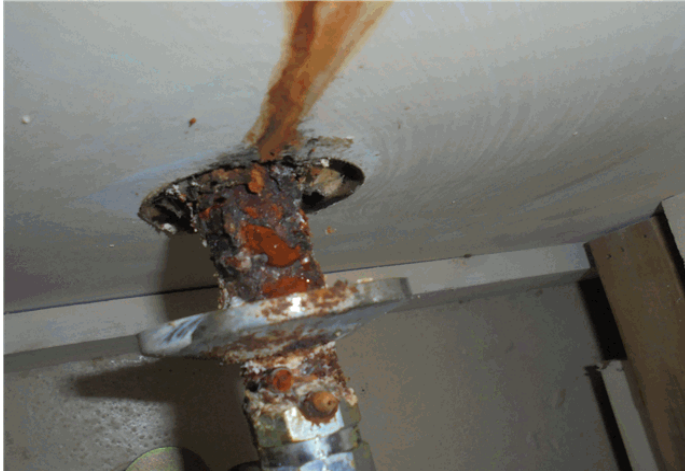
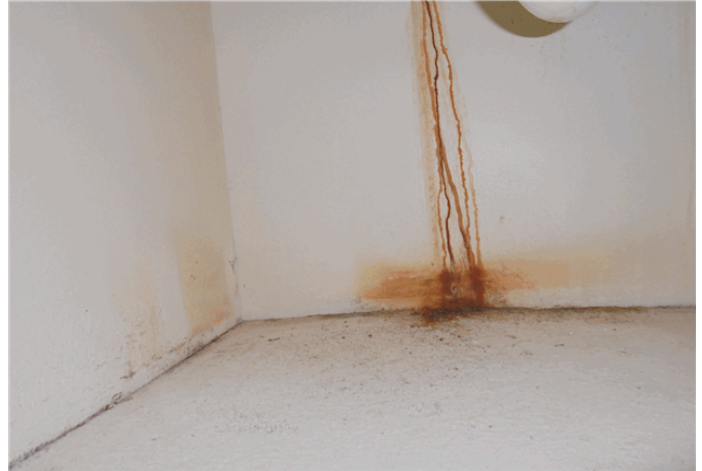
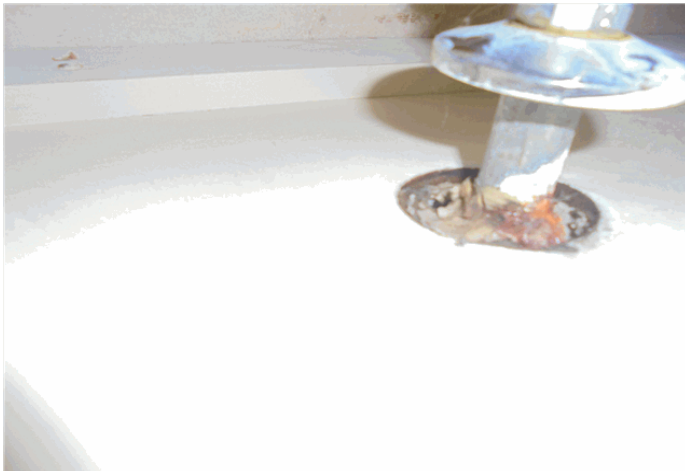
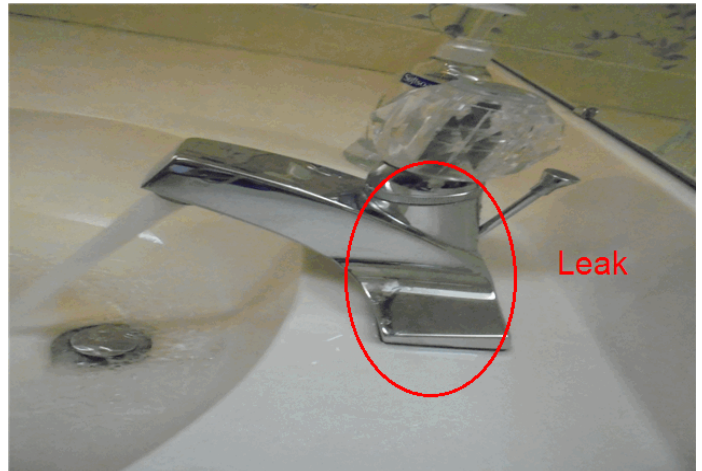
There was corrosion and damage at the hot water supply lines at both sinks in the master bath. This damage was observed where the hot water line comes thru the wall. There was a leak on the left faucet in the shared bathroom. It is suggested that a "Licensed Plumbing Contractor" be contacted for further evaluation and repair.
